# THIRD FIVE-YEAR REVIEW REPORT

## Bally Ground Water Contamination Superfund Site

Borough of Bally

Berks County, Pennsylvania

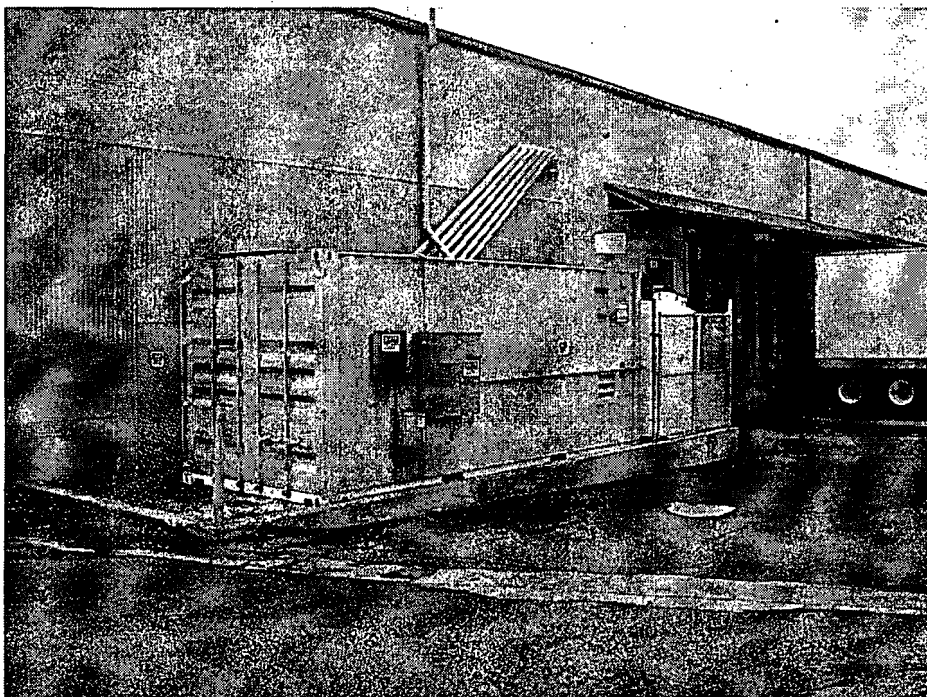
View of mechanical equipment associated with vapor intrusion mitigation system at former Bally Engineered Structures facility (April 2010).

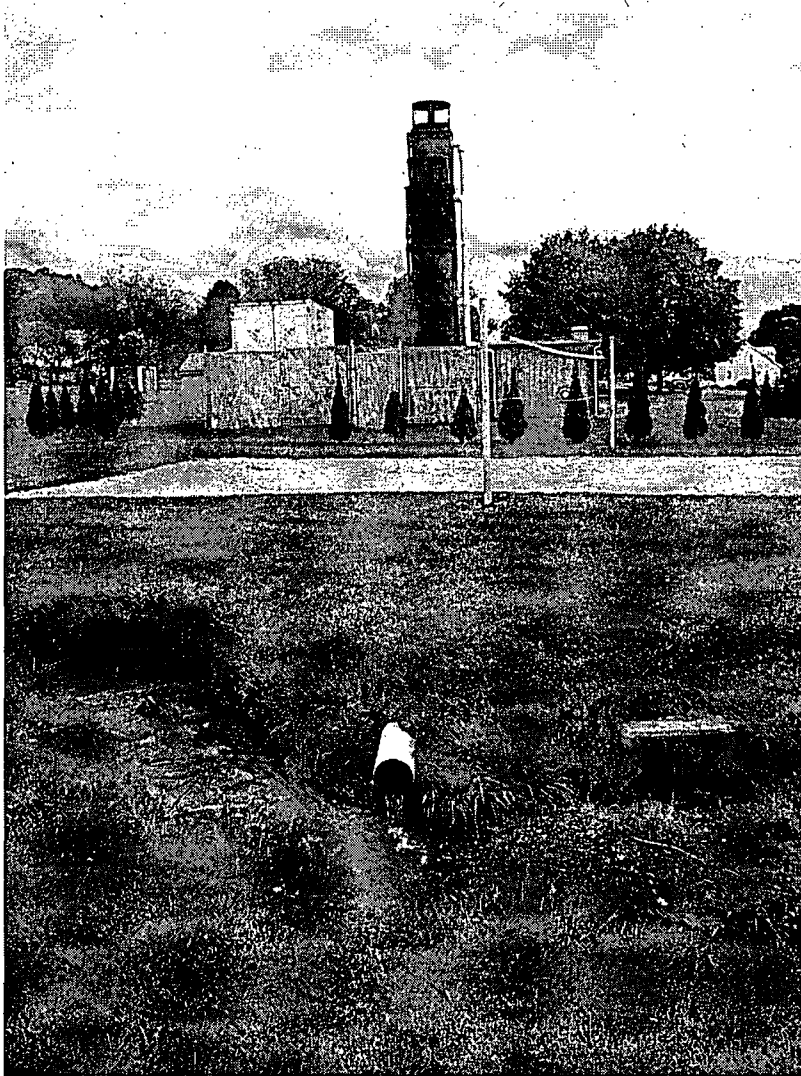
View of discharge pipeline from Municipal Well Number Three air-stripper treatment system to unnamed tributary of West Branch of Perkiomen Creek. (April 2010)

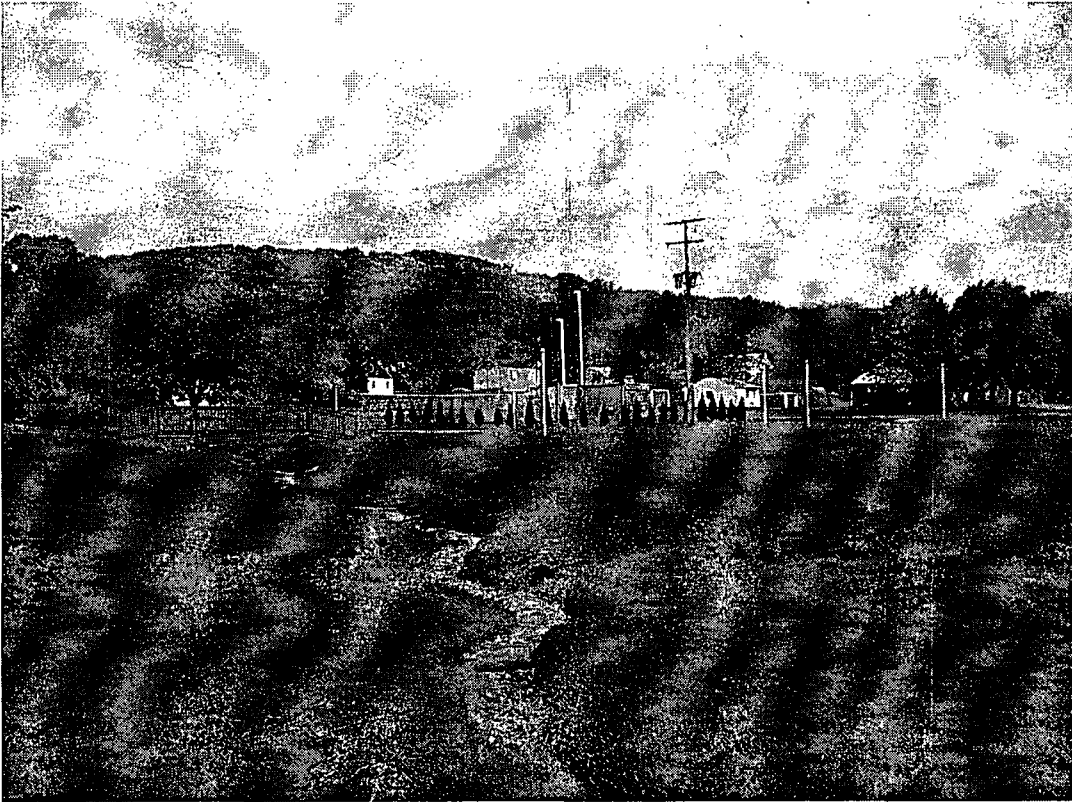
View of Municipal Well Number Three and associated air-stripper treatment system (two black vertical towers). (April 2010)

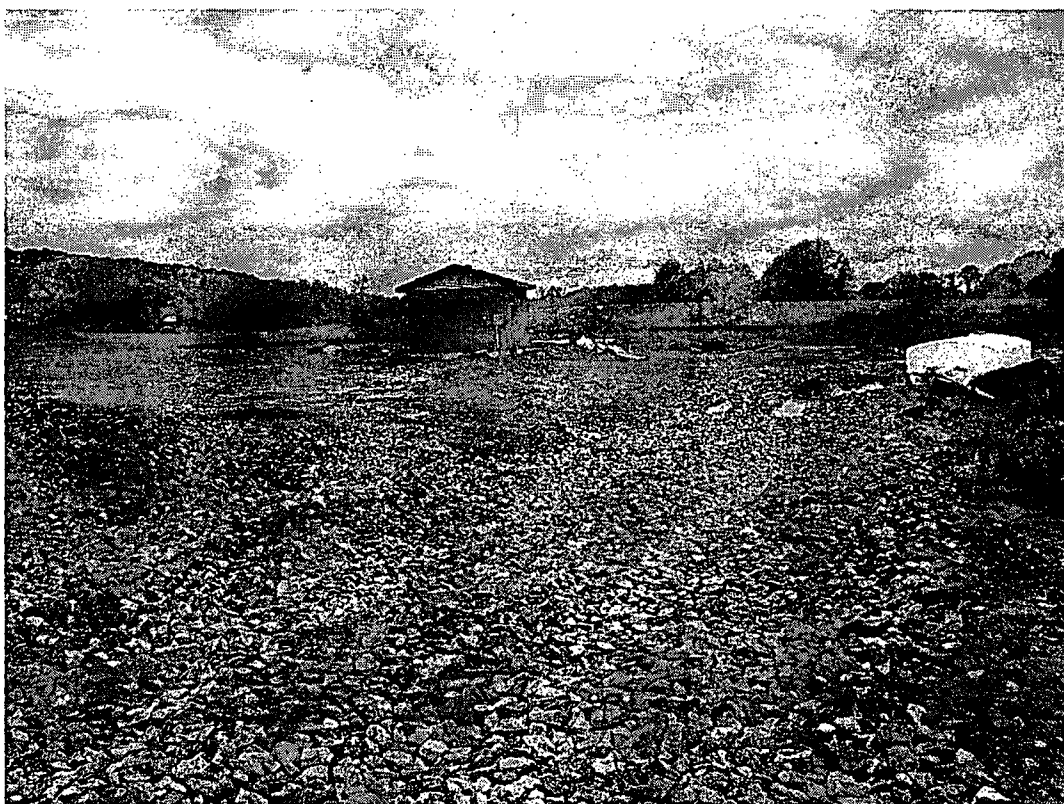
View of well house at new municipal supply well site. (April 2010)

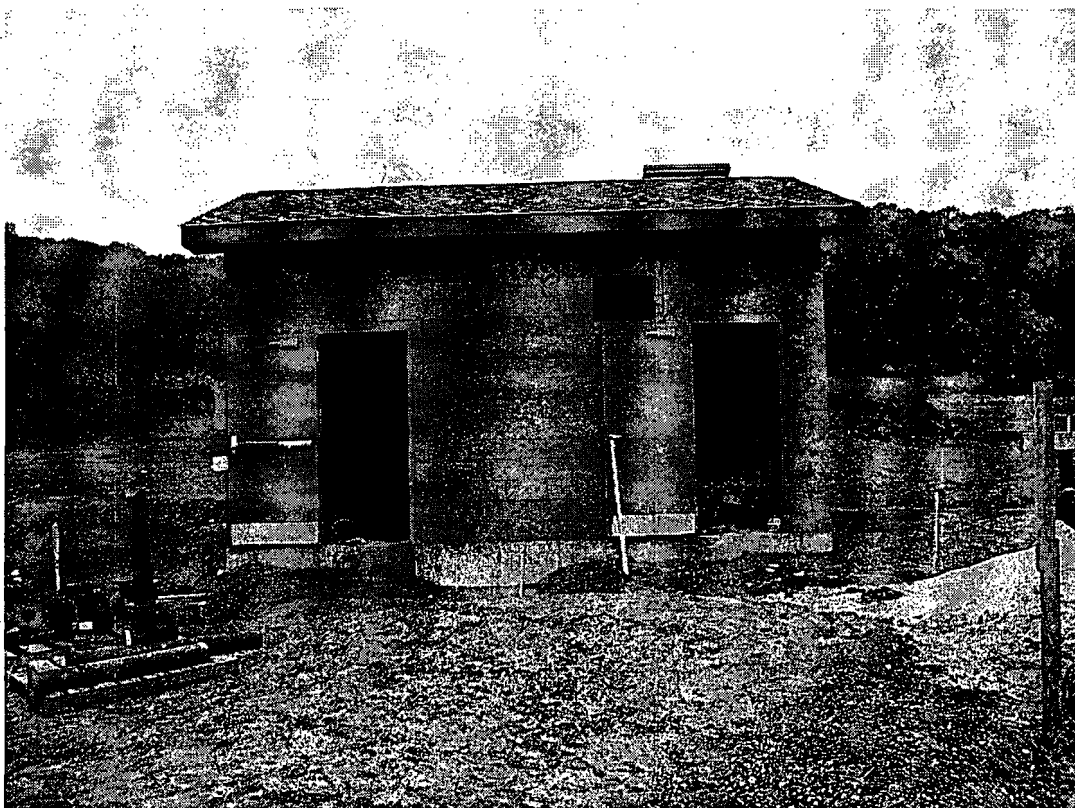
View of new well house. (April 2010)
